## ***Informe situación y pruebas CPU PEM***

Ref: CPU equipo XIS100XD  
Puerto Maldonado Falla  
de encendido/

**Reporte: AAP28E2015CPUPEM**

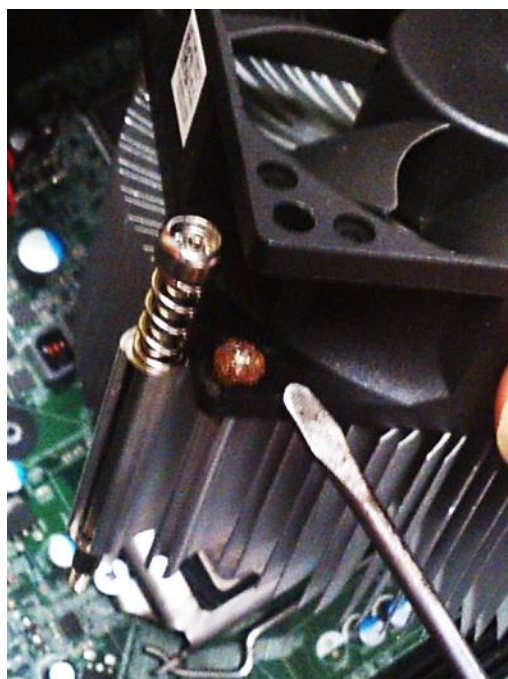
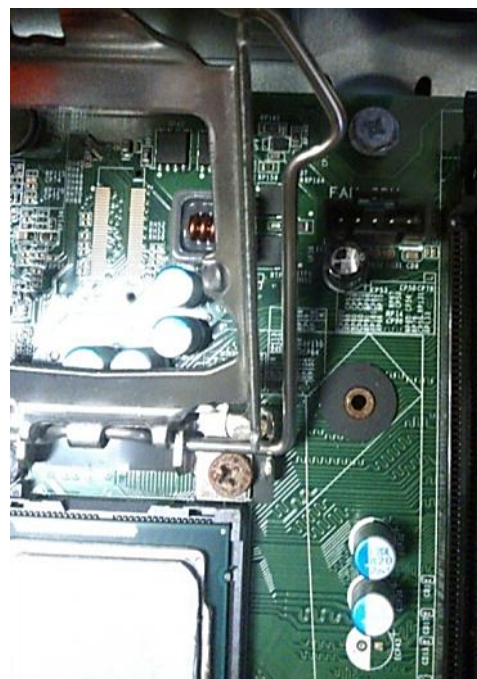
Tras abrir la unidad y observar su interior, se aprecia que pernos y componentes presentan corrosión oxidación, por lo cual se realiza entre otros.

## Oxidación Interna

- ✓ Limpieza completa en Slot PCI y Conectores.
- ✓ Reemplazo de pasta térmica en procesador
- ✓ Reprogramación del control de ventiladores a alta velocidad
- ✓ Instalación de secantes de silica
- ✓ Instalación de deshumificador iónico VCI

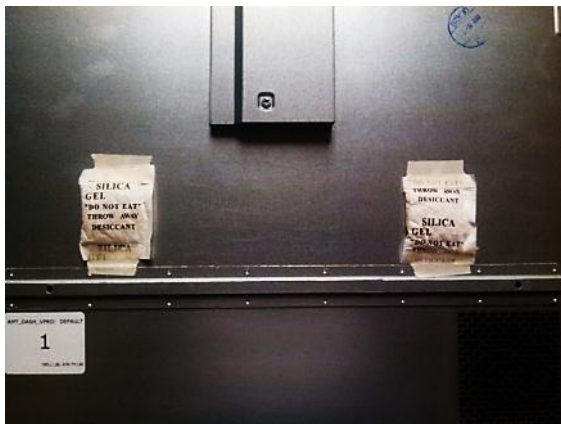
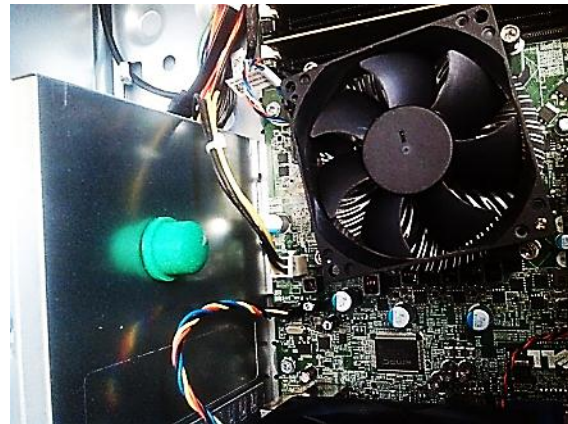
**Secantes de Silica y Secante Iónico VCI**

Hemos incorporado en el paquete (que desconocemos el estado de llegada, dado que LAN manipulo abriendo el empaque para el despacho), un secante iónico adicional, para ser adherido en la unidad cerca de la tarjeta DCI.

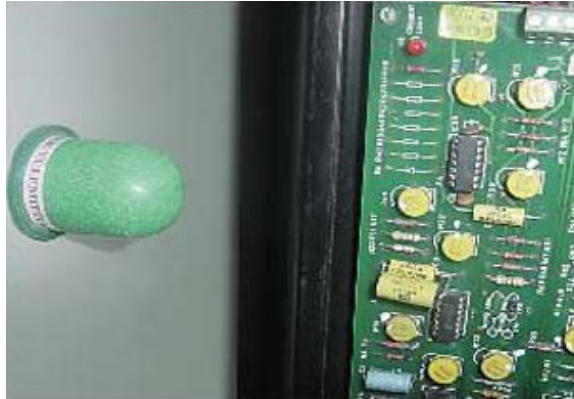
A mixture of special chemicals that constantly vaporize and create gases which have anti – corrosion properties. These vapors form a very thin protective film layer around the metal surface and prevent the metal from the corrosion action.

VCI chemicals dissociate into anions and cations with moisture as an electrolyte. These anions and cations associate with anodic and cathodic reactive areas respectively on the metal surface forming a mono-ionic protective layer, making it inert for any further reaction such as oxidation/rusting. Any loss of ions is replenished through further condensation of vapor ensuring continuous protection

VCI Emitters offers ideal protection to Under normal conditions it offers protection for 24 months. The molecular VCI layer does not affect the electrical, /optical & mechanical function of the equipments. VCI Emitters works well even in humid conditions and is unaffected by pollutants. Emitters are compact and space saving. The adhesive backing of emitters allows easy & quick installation. ot harmful to humans \*Free of nitrites, silicones and phosphates. and are environment friendly.
